PRE-CERCLIS SCREENING ASSESSMENT

Loewenthal Metals Corp.
947 W. Cullerton Street, Chicago, Illinois

Prepared by:
Illinois Environmental Protection Agency
Bureau of Land
Office of Site Evaluation

August 31, 2006

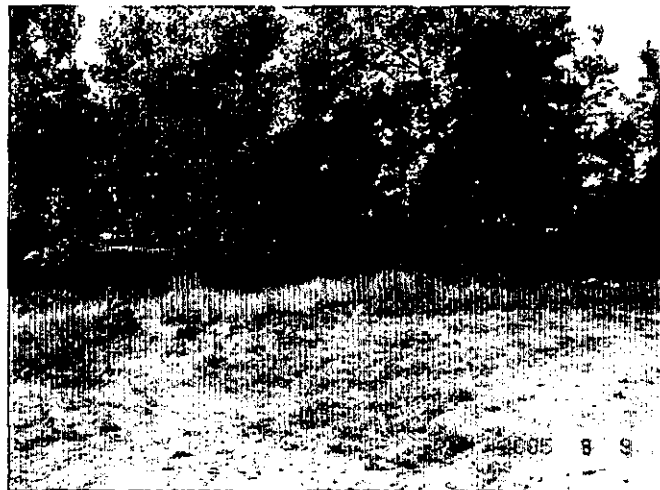
Date: 6/9/05
Time: 9:00 AM
Photo Taken By: Lance L. Range
Roll No. NA
Photo No. 2
Direction of Photo: South
Comments: Photo taken from middle of lot. There is a concrete structure present at the back of the lot. Railroad tracks are present in the trees also.

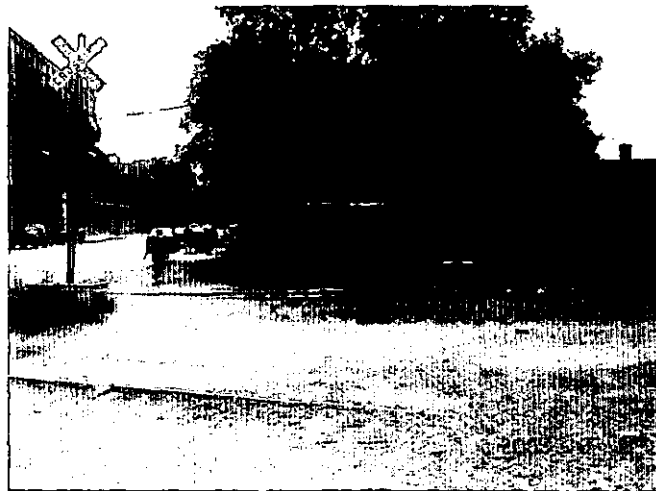
Date: 6/9/05
Time: 9:00 AM
Photo Taken By: Lance L. Range
Roll No. NA
Photo No. 4
Direction of Photo: East
Comments: Photo taken from the lot looking east. Beyond the RR tracks are residential homes and a school on the far corner. Many people walking on the site (no sidewalk) to and from school.

There is a residential apartment complex located directly to the west of the site (photo 1, page 11), with residential homes found adjacent (north) of the site (photos 6, 7 and 8, page 14 and 15). Rail road tracks are present on the east side of the site, followed by residential homes (photo 4, page 13).

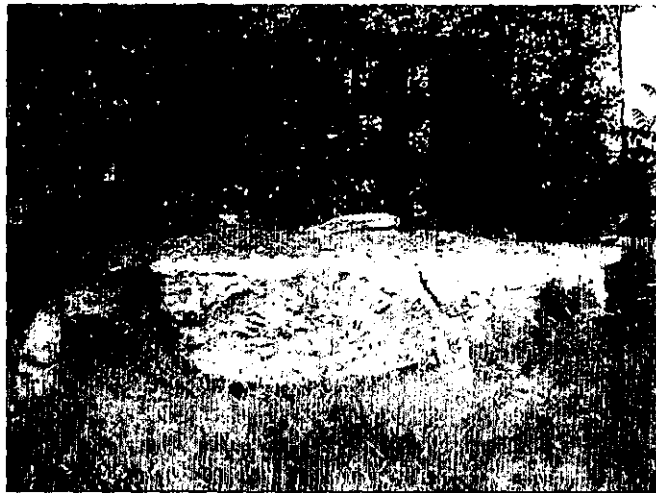
Date: 6/9/05
Time: 9:00 AM
Photo Taken By: Lance L. Range
Roll No. NA
Photo No. 9
Direction of Photo: west
Comments: Photo taken of the concrete platform located near the southern portion of the site. It is unclear if this structure was from the smelter or if some other type of building used for railroad purposes.

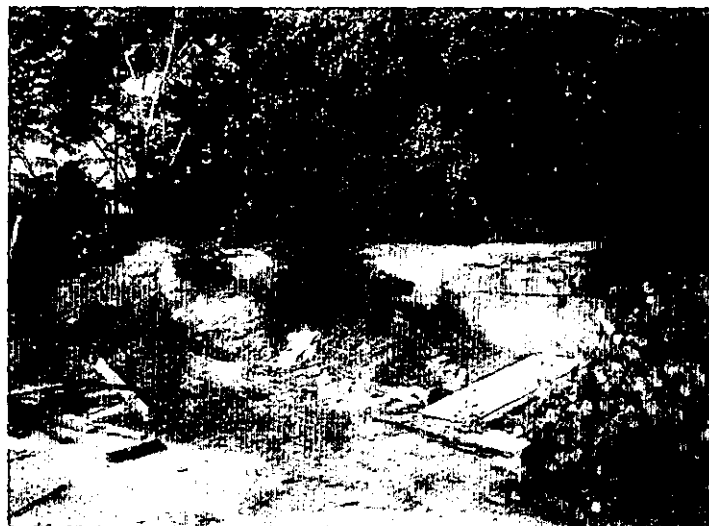
Date: 6/9/05
Time: 9:15 AM
Photo Taken By: Lance L. Range
Roll No. NA
Photo No. 10
Direction of Photo: South
Comments: Photo taken of the concrete platform. As you can see there is a dumping problem also in this area.

A reconnaissance trip was taken on July 15, 2006 to verify the conditions and locations of the former Loewenthal Metals Corporation. The site is presently an empty lot with a concrete platform in the southern portion of the site. There is also evidence of open dumping on the property (photo 10, page 16). A new residential complex has recently been built just west of the vacant lot (photo 1, page 13). To the east of the lot are railroad tracks followed by residential homes. The site is partially vegetated with exposed gravel and soil. Upon arriving at the site, it was determined that the southern edge of the property is being used for a walkway for children to and from school. There is not a sidewalk on the edge of this property. The presence of a tent/home-made structure near the south portion of the site indicated that the site is also being utilized by transient individuals.
